## **Upper A-Arm Performance Bushings Installation Instructions**

> 928 Motorsports 604 E Mapl e St, Horicon, WI 53032

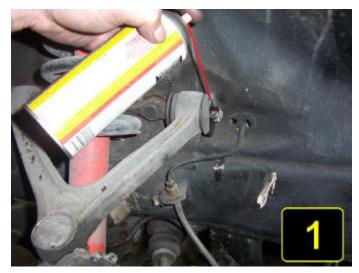
Lubricate the nuts on the end of the upper A-Arm Spindles with your favorite spray lubricant.

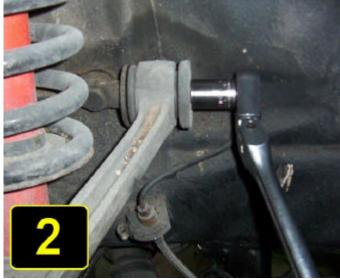
We recommend that you break torque on the 19mm nuts on the ends of the upper A-Arm Spindle now, while the Upper A-Arm is in the car. This will save you a lot of work later. Do not remove the nuts at this time, just break them loose.

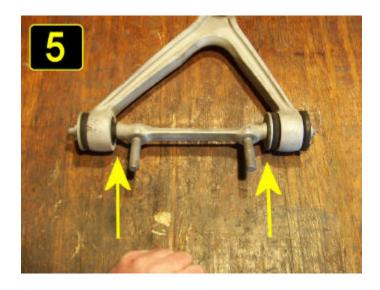
Take a look at the upper A-Arm on the bench and take note of where the arrows are pointing in picture #5. You will notice that there is a large steel washer on the inside of one arm, but not the other. This tells us which way the spindle is going to be removed from the upper A-Arm. The spindle is removed out through the arm that has no washer on one side. In this picture, #5, that means that the spindle is going to be removed out through the left arm as it appears here.

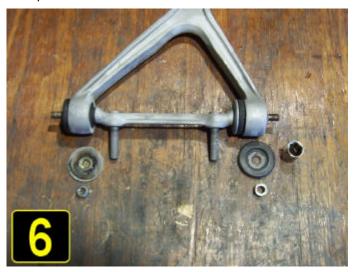
Picture #6. Remove the 19mm nuts (that you previously loosened in step two) from the spindle. At this time, your A-arm will look like picture #6.

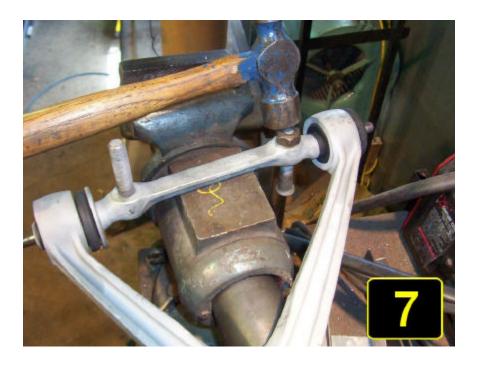
Picture #7. Re-thread the 21mm nut back on the mounting bolts nearest the side with no inside washer (from picture 5) and wrap the mounting bolt sharply with a hammer to drive it out of the spindle.

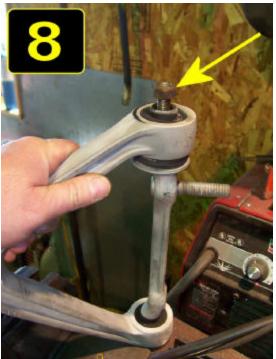
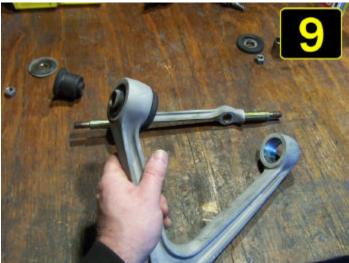
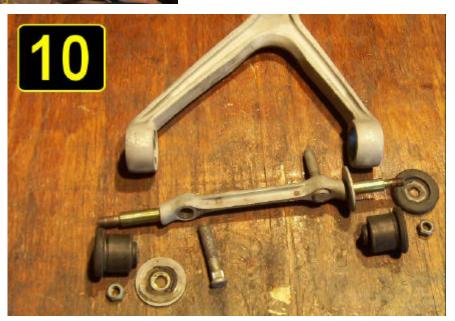
Picture #8. Thread one of your 19mm bolts back on the end of the spindle and strike it sharply with a hammer to drive the spindle out through the frame. Then you can remove the spindle from the A-frame and it will look like picture #9. Use a drift and drive out the other rubber bushing on the other side and lay out all the parts on the bench. At this time your upper A-Arm with the bad bushings should look like picture #10.

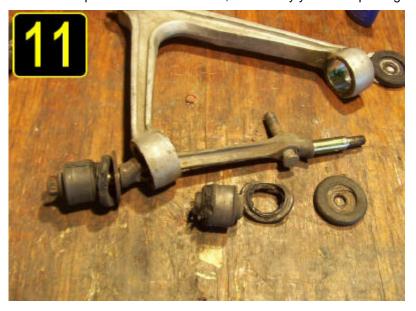
Picture #11. Sometimes the bushings are going to come out very hard and torn because they're broken, hardened old rubber as shown in picture #11. That is OK, that is why you are replacing them!

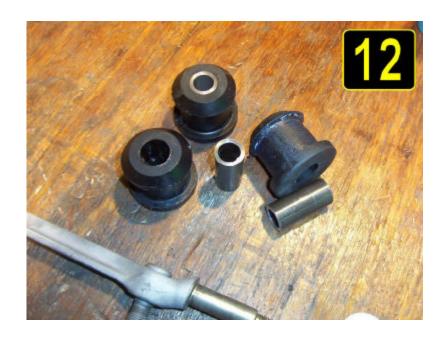
Picture #12. Take the new polyurethane bushings and push the inner steel sleeves out of the polyurethane with your thumb. They will push right out. This will help make it easier to compress the bushing to get it into the A-Arm.

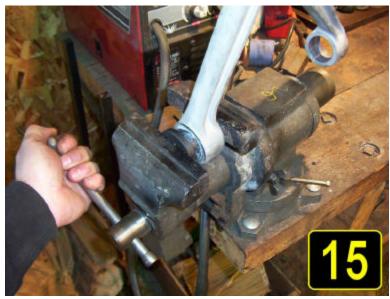
Picture #14. Put the A-Arm and a bushing in a vise and use the vise to press the bushing into the upper A-Arm.

Picture #15. With a vise you won't be able to push the bushing all the way through the A-Arm, but you can certainly get it started and just rap it into place the rest of the way with a hammer.

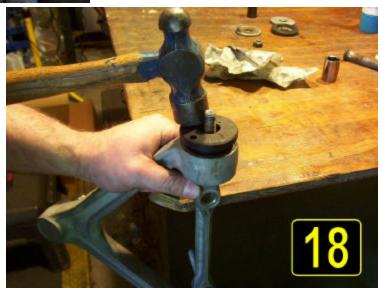
Picture #17. Use the vise and start the other side of the polyurethane bushing into position.

Picture #18. The vise will push it only so far, then remove it from the vise and just rap the bushing the rest of the way into place with a hammer.

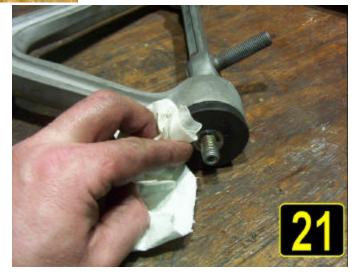
Picture #20. Tapping the center sleeve into the polyurethane bushing.

Picture #21. Wipe off all the excess grease.

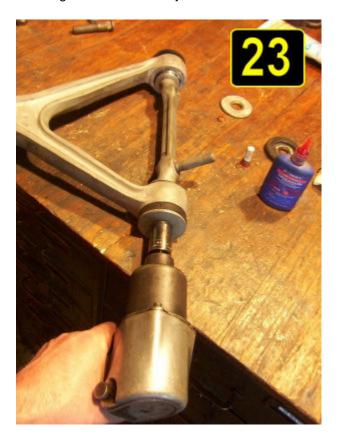
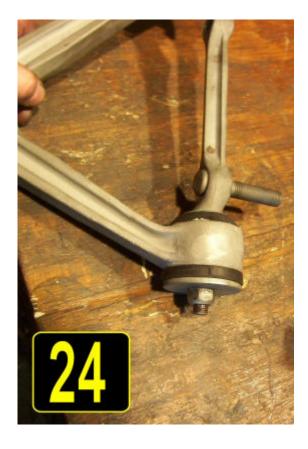
Picture #22. These are the three washers that you removed when you dis-assembled the upper A-arm in step #10. Note, that one of the washers has a large hole. Two of the washers have a small center hole. The one with the large hole will not be going back on.

Picture #23. Install one of the washers that we are going to use from picture #22 on the end of the spindle and put the 19mm nut back on. When it is finished, it should look like picture #24. Follow the same process with the other side. When using the washer with the molded rubber on it, you can either remove the rubber with a pocket knife, or just flip the washer over and put the steel flat side against the bushing and use it that way.

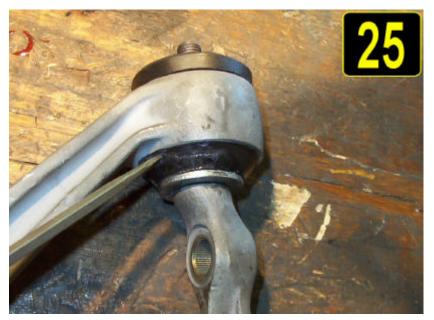
Picture #25. Take a screwdriver and gently make sure that the clamping collar of the polyurethane bushing is out and all the way around the A-Arm bushing. If needed, you can loosen the nut you tightened in step 23, pry this lip out with a screwdriver as shown, then re-tighten the nut.

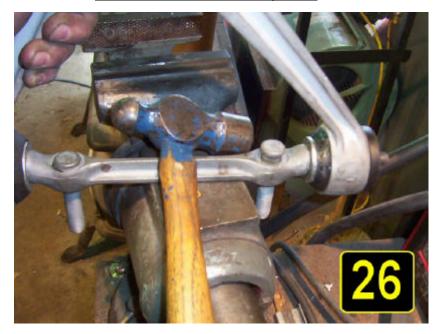
Picture #26. Now put the mounting bolt back in place in the spindle that we removed in picture #7 and knock it in place with a hammer. Make sure to seat it all the way down.
